AFWAL-TR-85-2097

IMPROVEMENT OF THE CORROSION RESISTANCE OF TURBINE ENGINE BEARINGS

April 1986

Final Report for Period August 1981 - August 1985

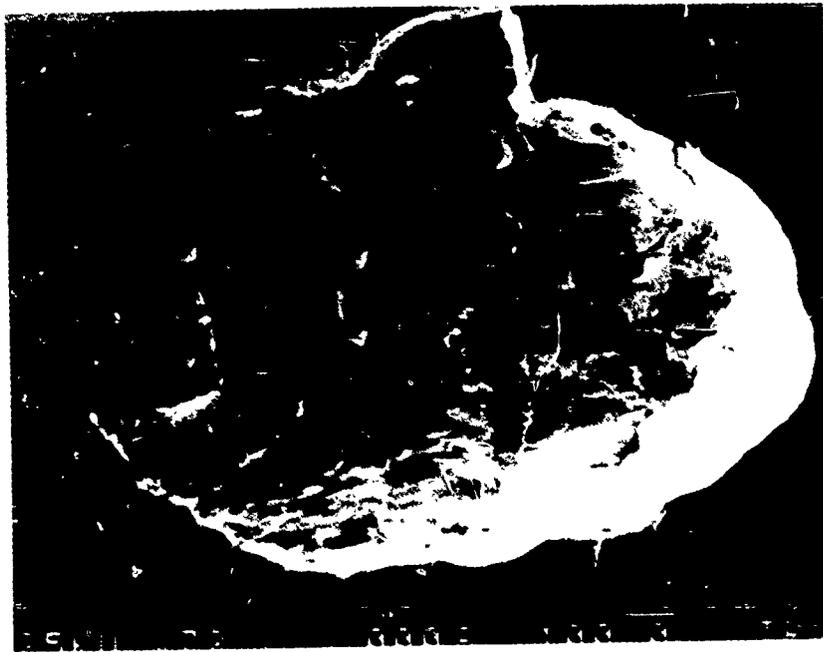
Figure 73. — SEM View of Spall in CRB7 Test Bar HC-2 (Magnification: 72 \times)

Figures 71 through 76 are SEM photographs of typical fatigue spalls from Rc test bars of M50 and five candidate materials. (Nickel sputter-coated M50 is omitted here because the nickel coating has disintegrated from the contact zone before fatigue failure.) The photos demonstrate that the same type of failure mechanism was at work in all materials. Failure initiated at a point, then progressed in a somewhat fan-shaped pattern in the direction of rolling. In Figures 71 and 76, flaking started near the bottom of the photos and progressed toward the top. In Figure 72, failure initiated at the top of the photo. In Figures 73, 74, and 75, spalling progressed from left to right. All show further cracks developing from the spalls. In each case the time lapse from the start of flaking until rig rotation stopped was a matter of seconds.

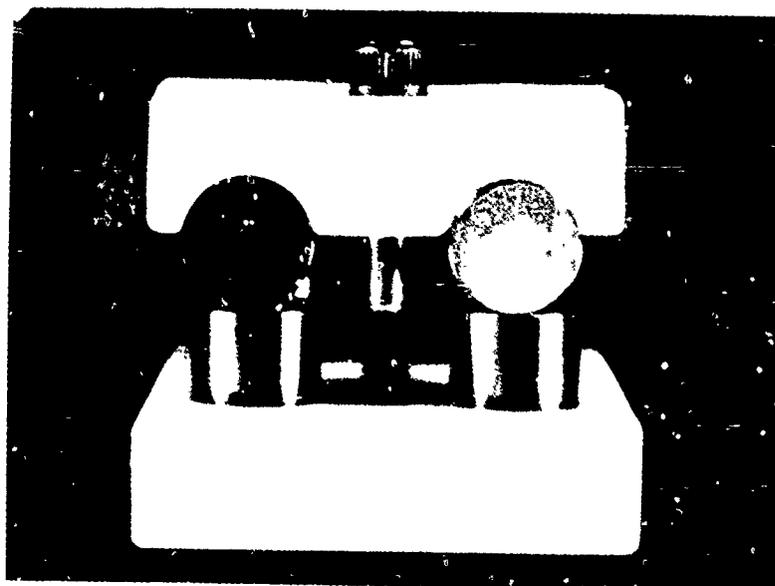
Specimens were installed in fixtures, Figure 77, so that they could be tested in pairs. The cylindrical surface of one specimen was pressed against the flat surface of another. Each pair consisted of like materials. Four pairs were installed in each of six fixtures so that 24 pairs of specimens were tested at a time. Typically, there were three pairs of samples of one material tested simultaneously; these three pairs were spread among the six fixtures so that there was no more than one pair of a particular material in a single fixture.

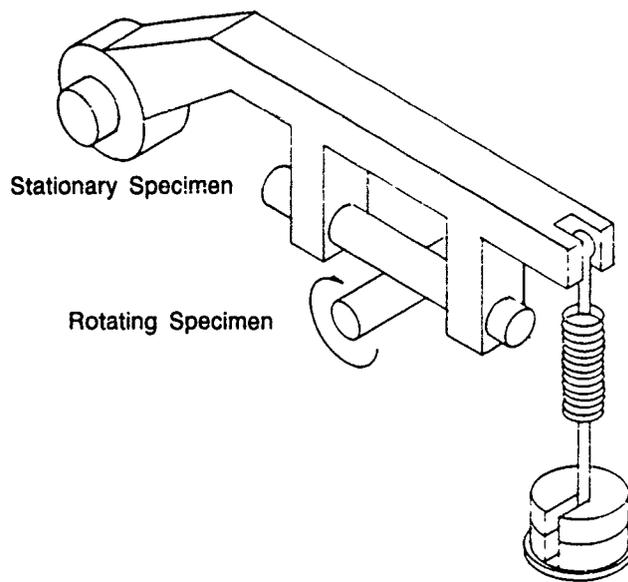
Figure 83. — Schematic of Wear Test Apparatus

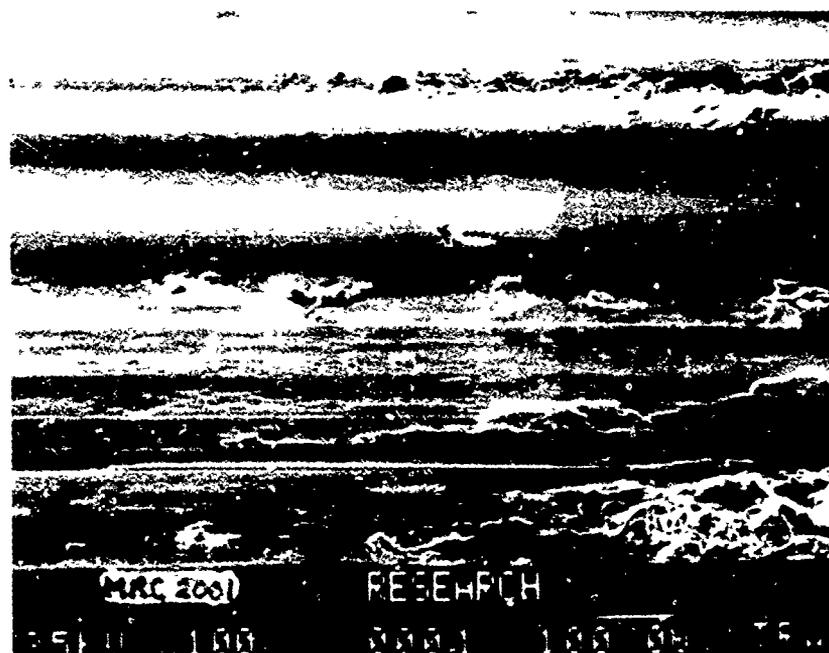
Figure 93. — SEM Photograph of the Bottom of a Typical Wear Scar on an MRC2001 Stationary Bar (Magnification: 100X)

Figures 92, 93, and 94 are SEM photographs of representative wear scars on the stationary bars of M50, MRC2001, and CRB7, respectively.

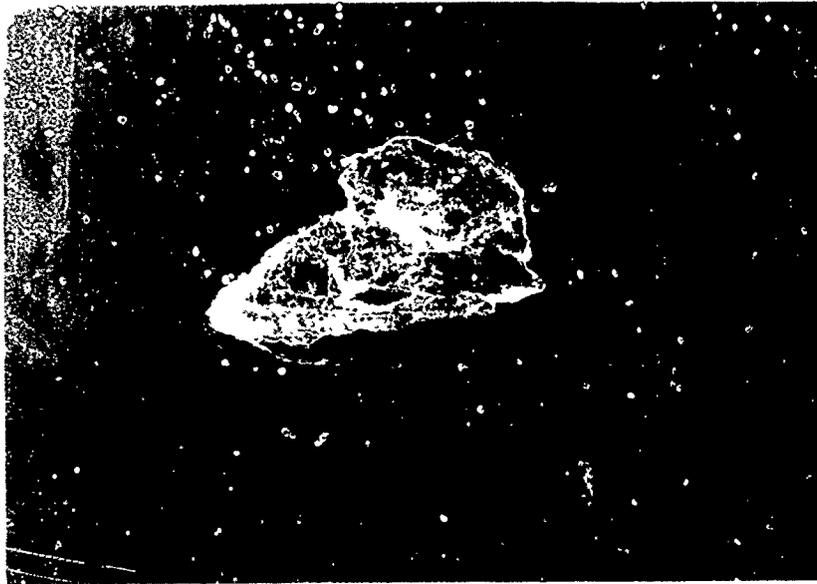
Inner Race Spall (20×)

E20 Inner Race Spall Cross Section (100×)

Figure 110. — MRC2001 35-mm Endurance Bearing S/N E20 Spalled Inner Race

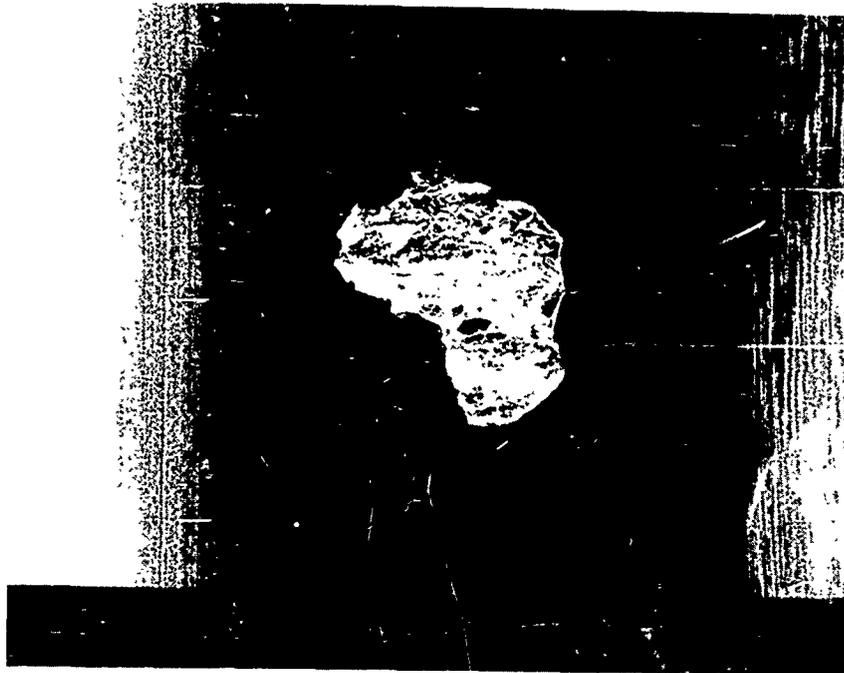
Figure 111. — MRC2001 35-mm Endurance Bearing S/N E12 Outer Race Spall (20 \times)

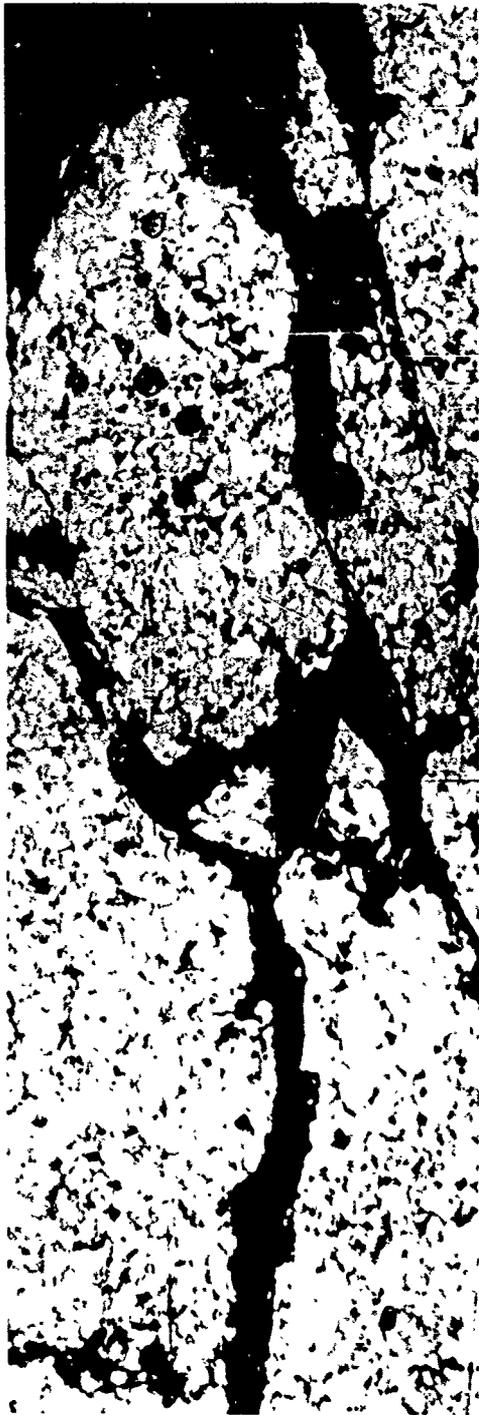
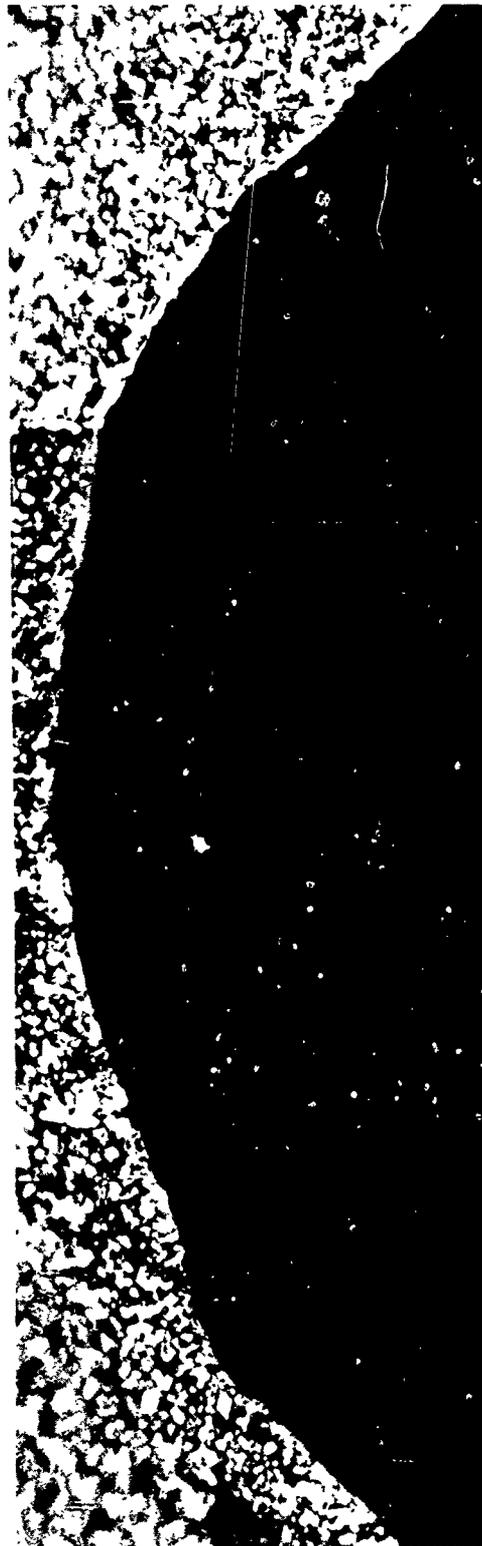
Secondary Cracking Around Fatigue
Spall of 35 mm Bearing Inner Race
Nital-Picral Etch

Figure 114. — Photomicrograph of Primary Fatigue Spall of MRC2001 RCF Specimen
and MRC2001 Inner Race

Secondary cracks adjacent to the primary bearing fatigue spall followed prior austenite grain boundaries (Figure 114). The cracks only followed a martensite-carbide boundary when a grain boundary was also present. This type of fracture path has been observed in the past for other powder metallurgy high chromium bearing alloys. It was not possible to precisely determine the fracture path of the primary spall on either the RCF bar or the bearing, however, the fracture path for both spalls appeared to also follow the prior austenite grain boundaries. The RCF bars did not exhibit secondary cracking around the primary spall possibly because there was less secondary damage after the spall.

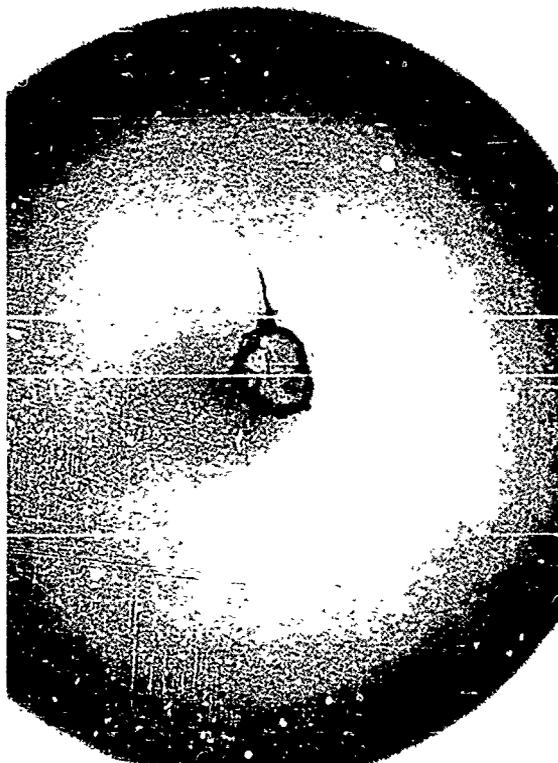
RSP565 Inner Race
Spall S/N 3
Endurance Time 1716.7 Hours
10X

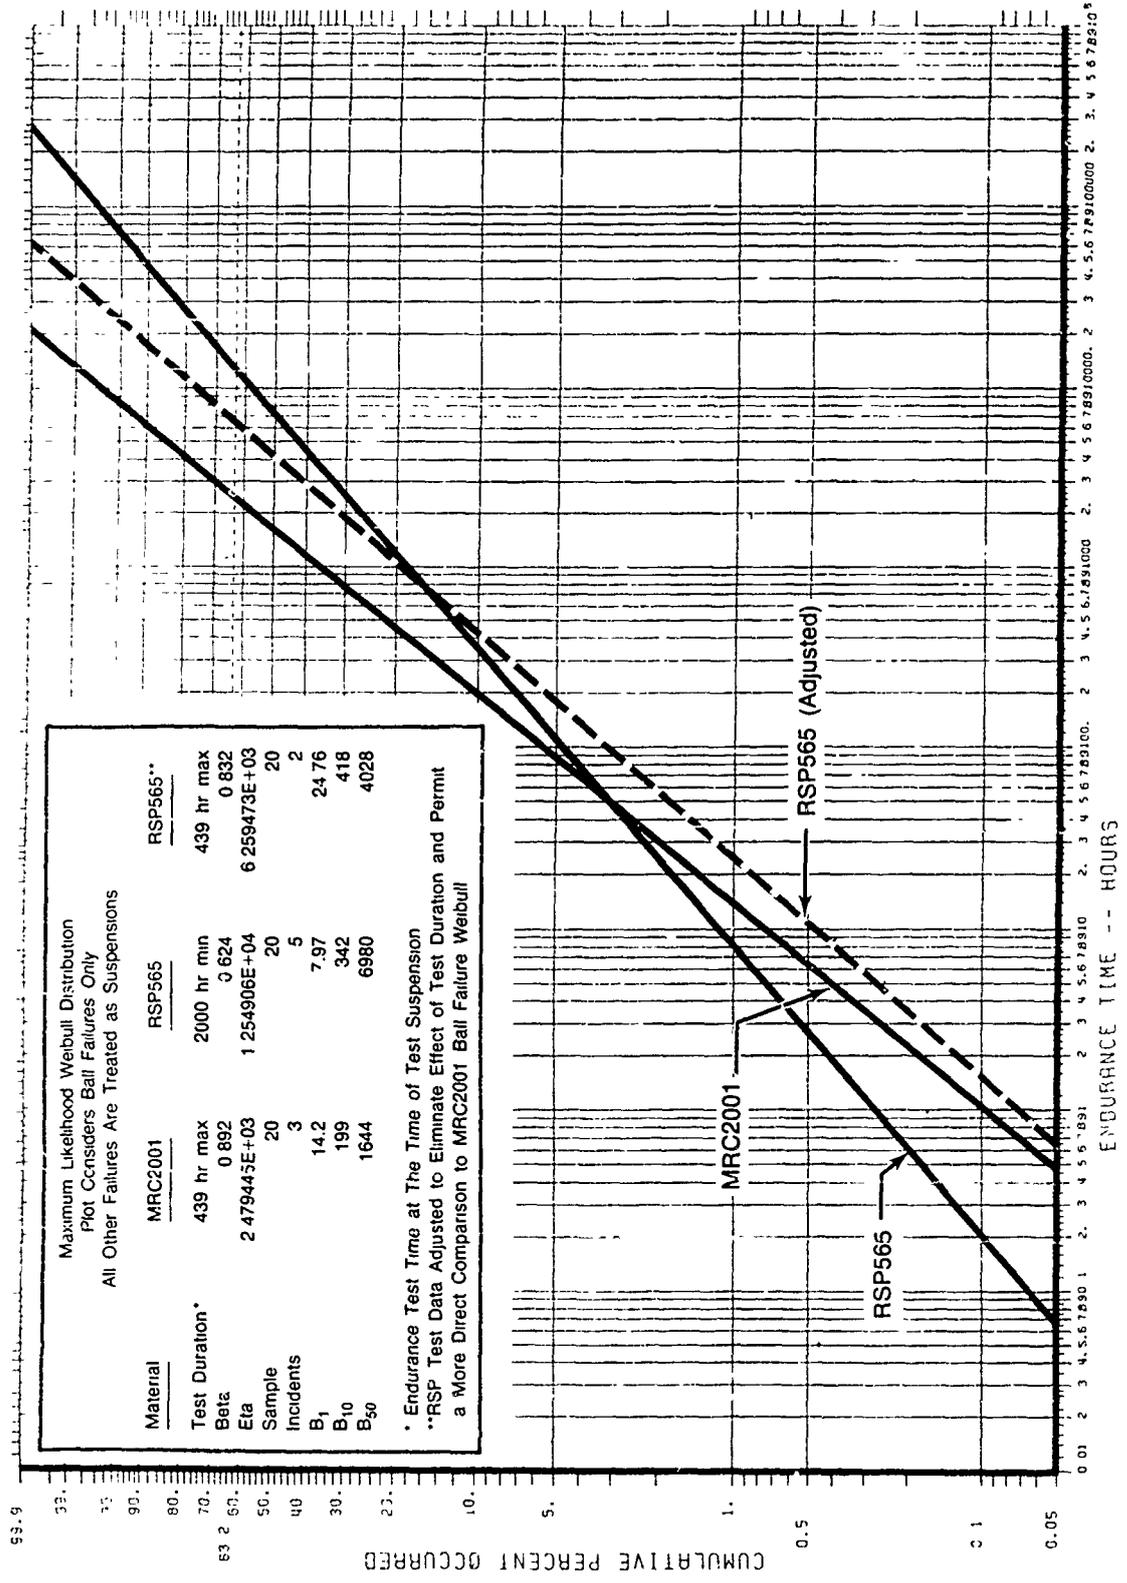
Maximum Likelihood Weibull Distribution
Plot Considers Ball Failures Only
All Other Failures Are Treated as Suspensions
